FLIGHT MEASUREMENTS OF THE RUDDER CONTROL AND SIDESLIP

CHARACTERISTICS OF FOUR VERTICAL TAIL ARRANGEMENTS

ON THE P-40 SERIES AIRPLANES -

MEMORANDUM REPORT

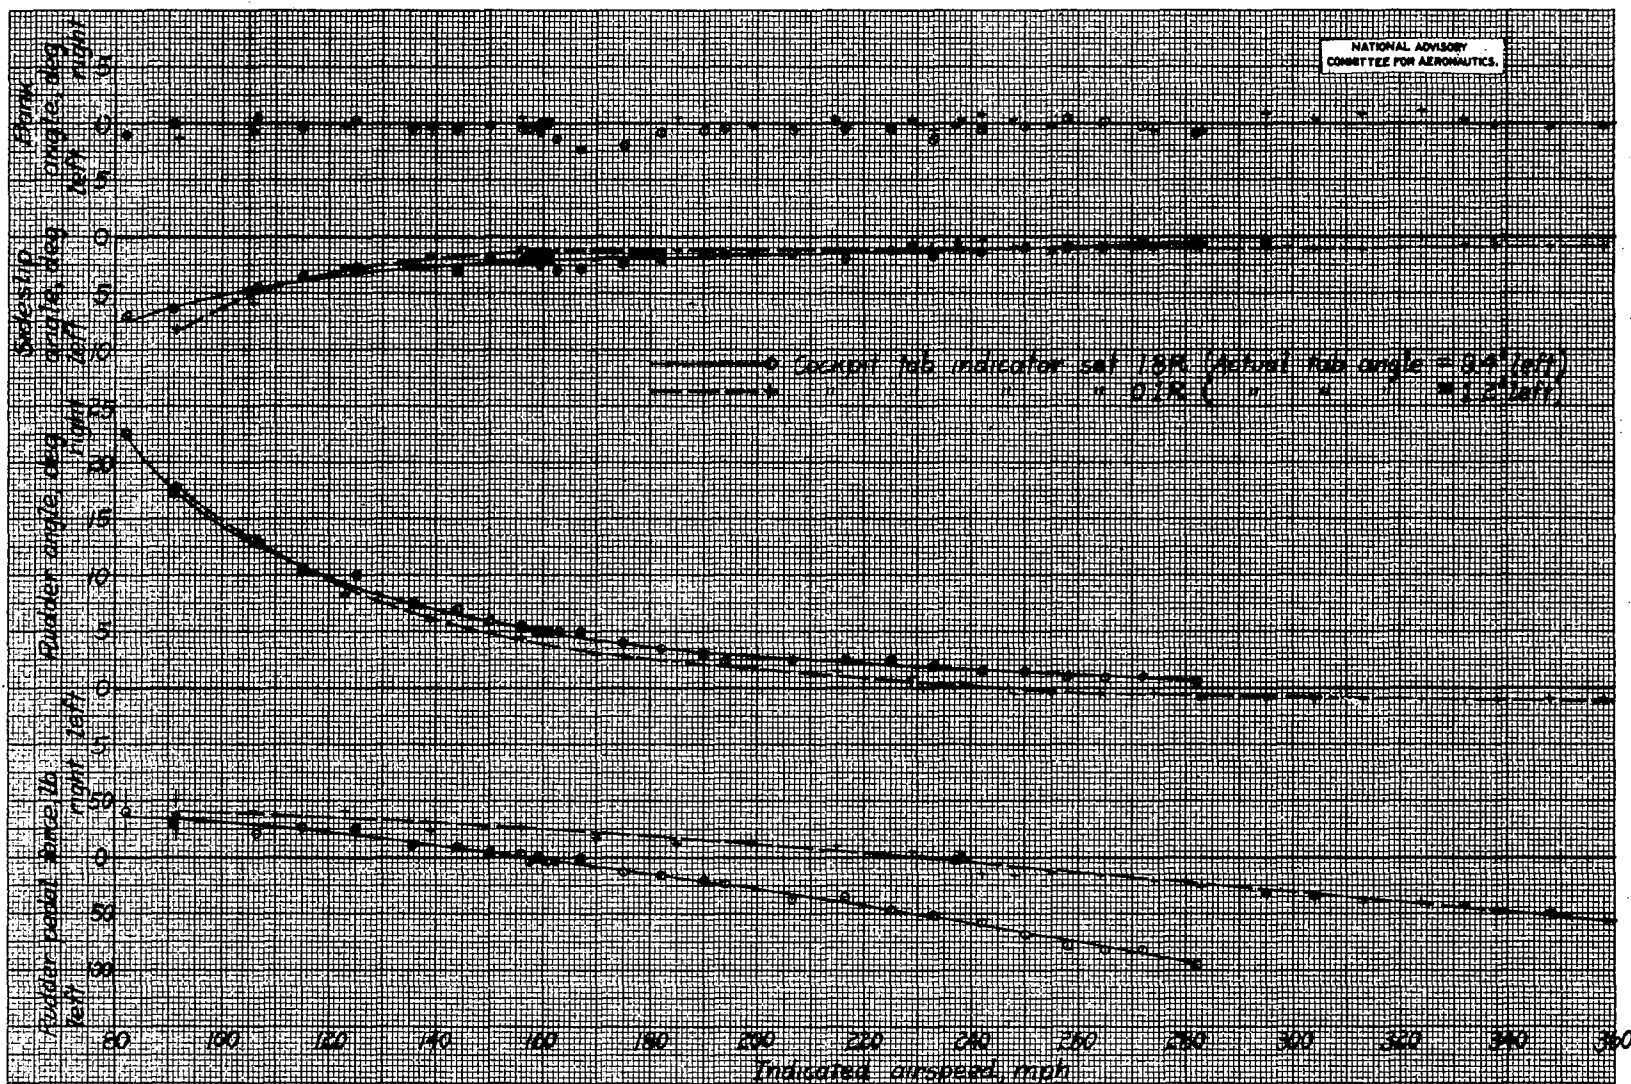
FIGURE 19. - Directional trim characteristics, P-40C airplane, fin extension No. 5 on tall vertical tail, fin effect 0, power, clean condition.

The rudder-control characteristics in straight flight are presented for the four vertical tail arrangements tested in figures 12 through 23. The effectiveness of the rudder trim tabs as a function of indicated airspeed is shown on figure 24.

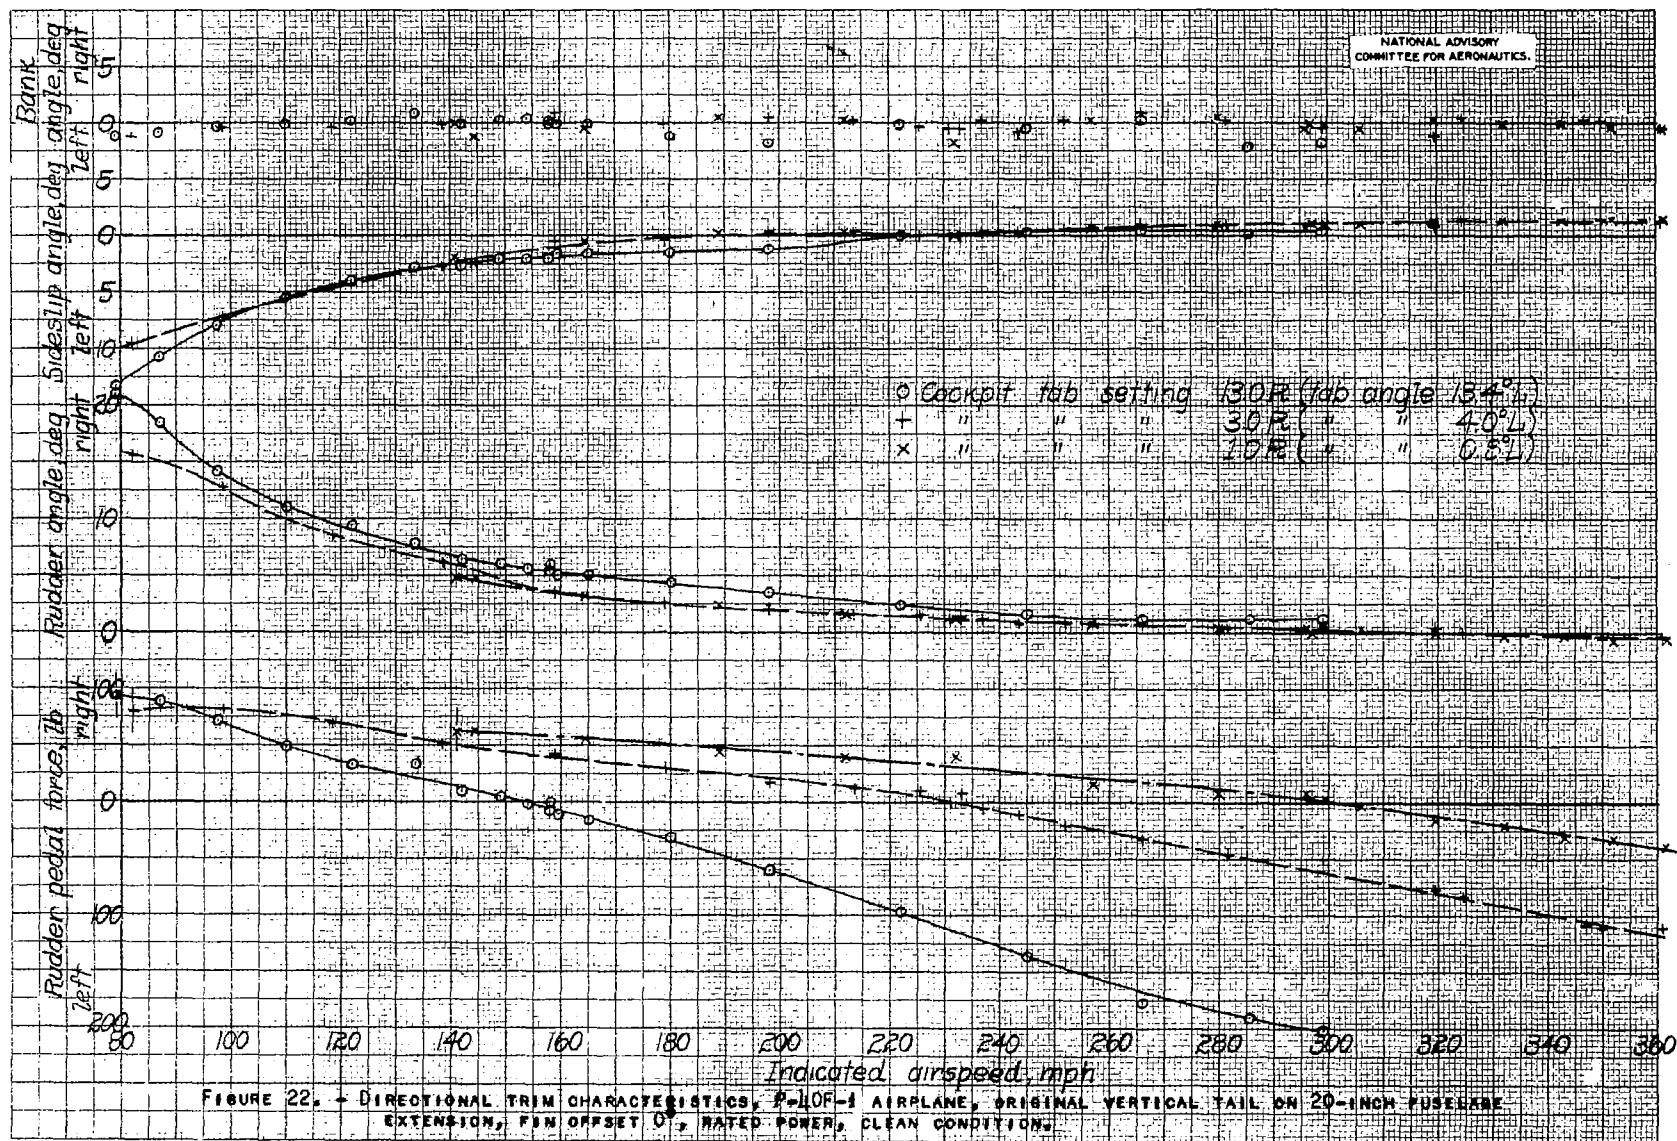
FIGURE 22. - DIRECTIONAL TRIM CHARACTERISTICS, P-10F-1 AIRPLANE, ORIGINAL VERTICAL TAIL ON 20-INCH FUSELAGE EXTENSION, FIN OFFSET 0°, RATED POWER, CLEAN CONDITION.

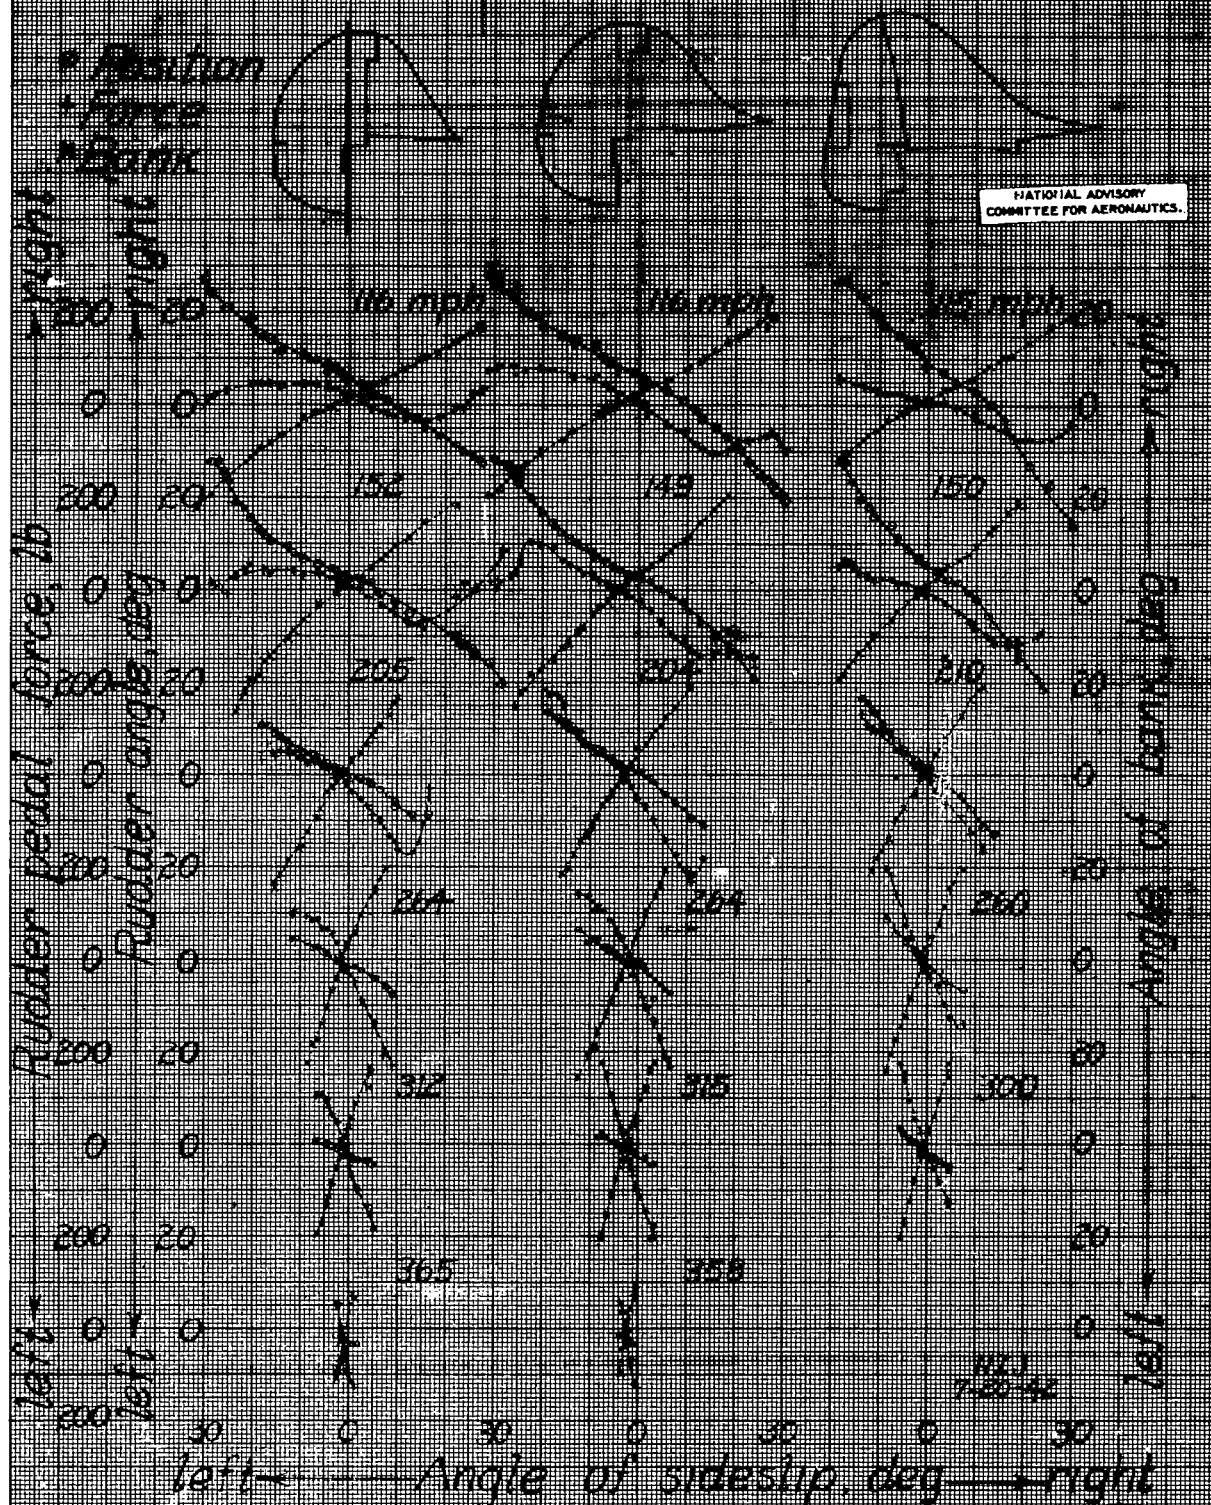
Figure 25 - Sideslip Characteristics of a P-40E Airplane at Various Indicated Airspeeds with Rated Power

P-40E
Fin Offset $1\frac{1}{2}^\circ$
Balance Tab
Original Fuselage

P-40F-1
Fin Offset 0°
No Balance Tab
 20° Fuselage Extension

The sideslip characteristics of the tail arrangements tested are shown in figures 25 and 26. Attention is

called to the rudder force reversals encountered in the lower speed range with rated power on with the original P-40E airplane. Sideslip characteristics for small angles of yaw are shown for all the tail configurations in figures 27 and 28.

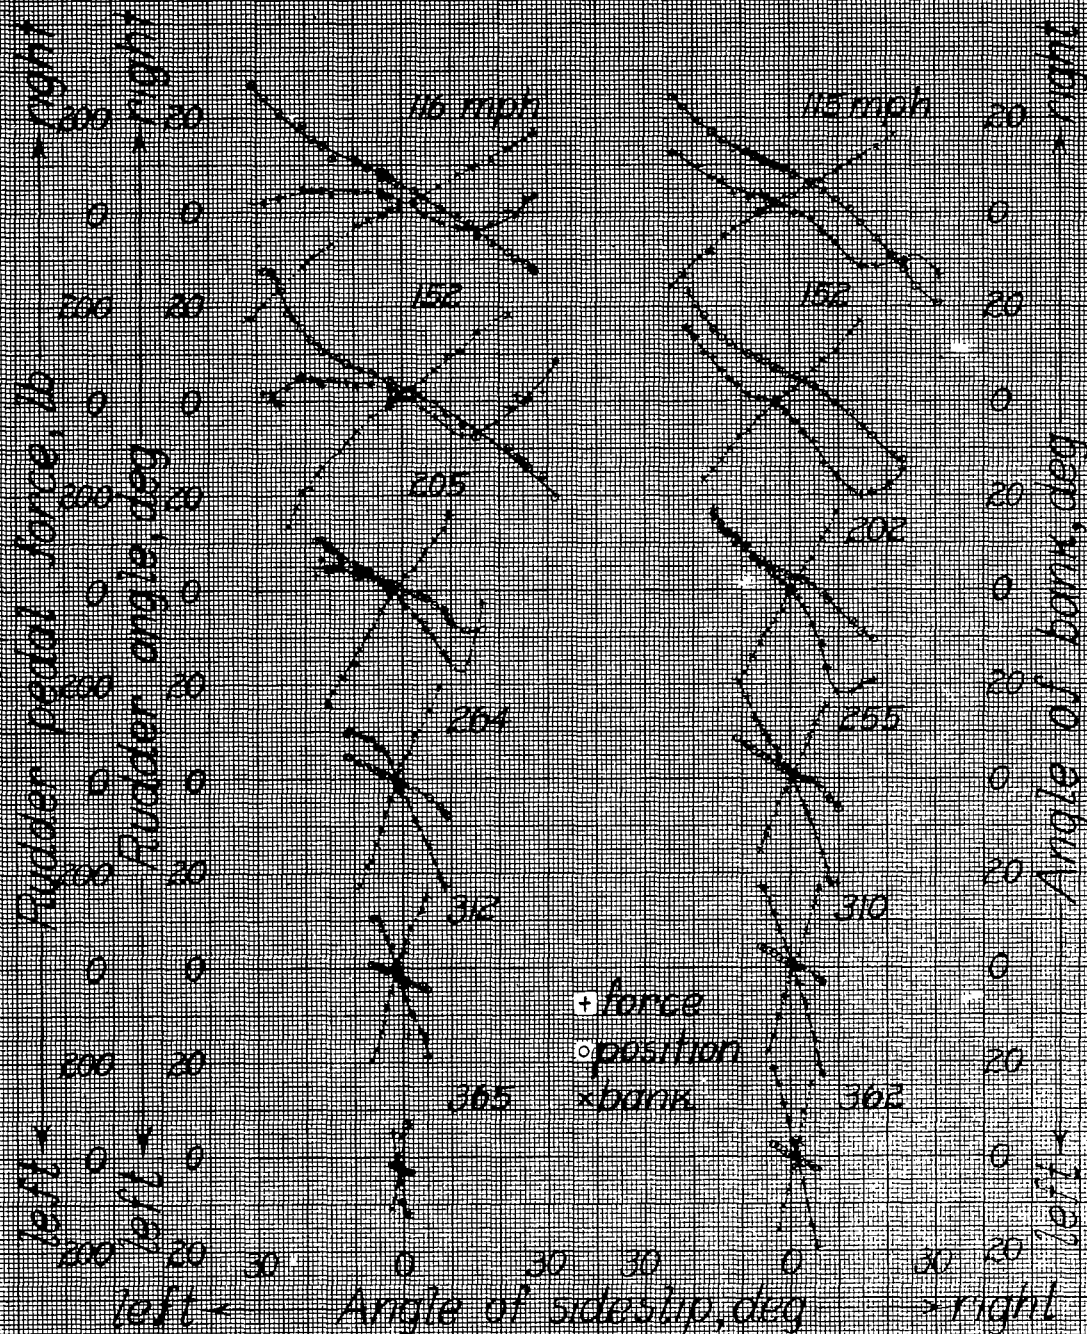
Figure 25a-Sideslip Characteristics of P-40E and P-40F-1 Airplanes with Original Vertical Tails at Various Indicated Airspeeds with Rated Power

Original Tail	Fin Ext No 1	Fin Ext No 6
Fin Offset $1\frac{1}{2}^\circ$	Fin Offset $1\frac{1}{2}^\circ$	No Fin Offset
Balance Tab	Balance Tab	No Balance Tab

- Position
- Force
- Bank

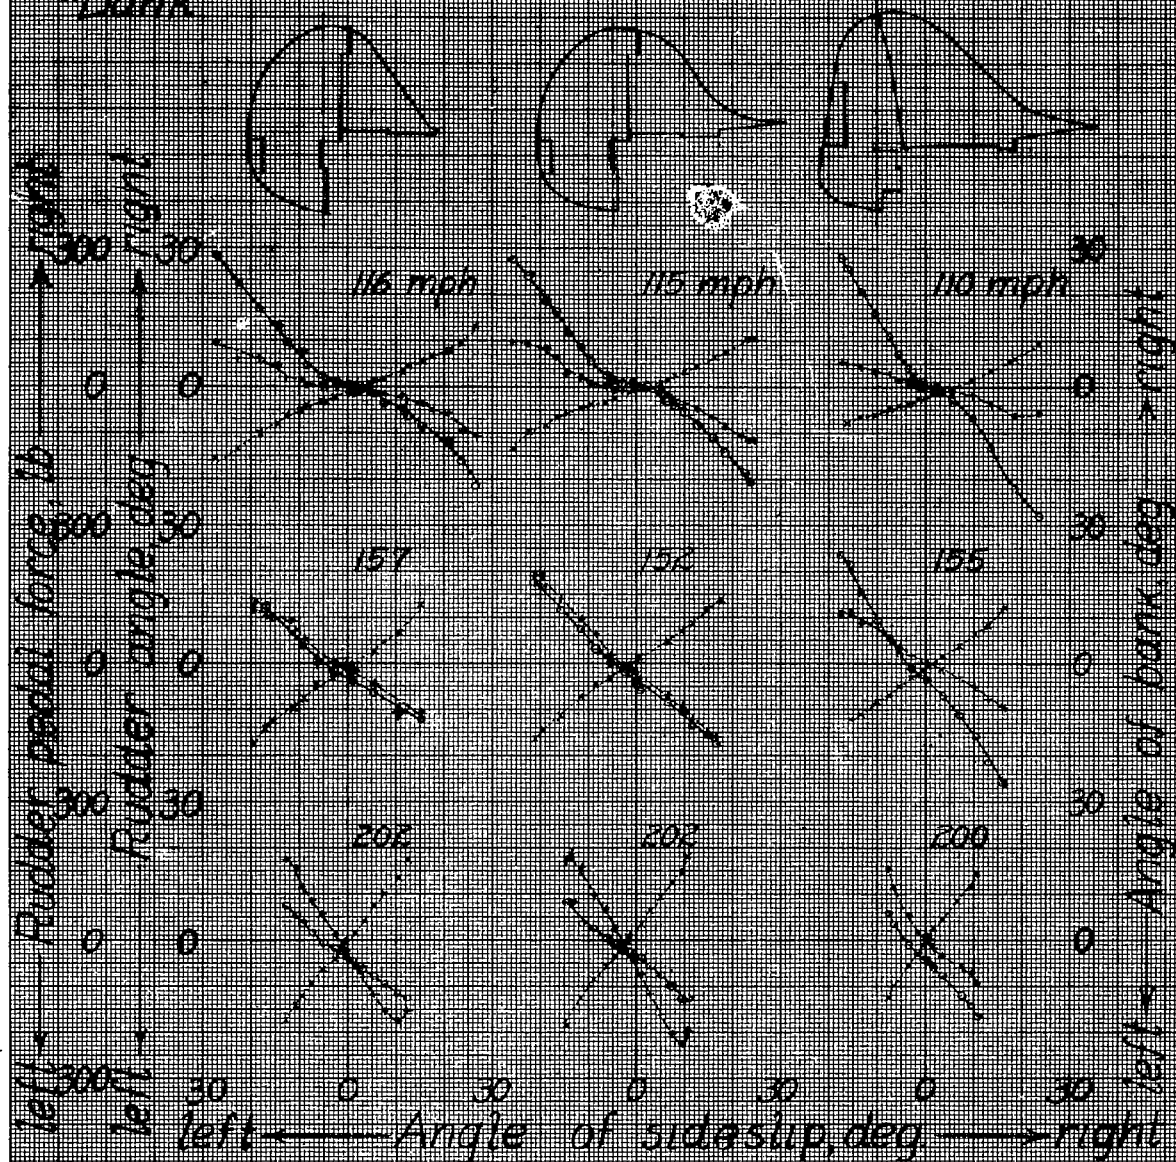
Figure 26 Sideslip Characteristics of a P-40E airplane at Various Indicated Airspeeds with Power off.

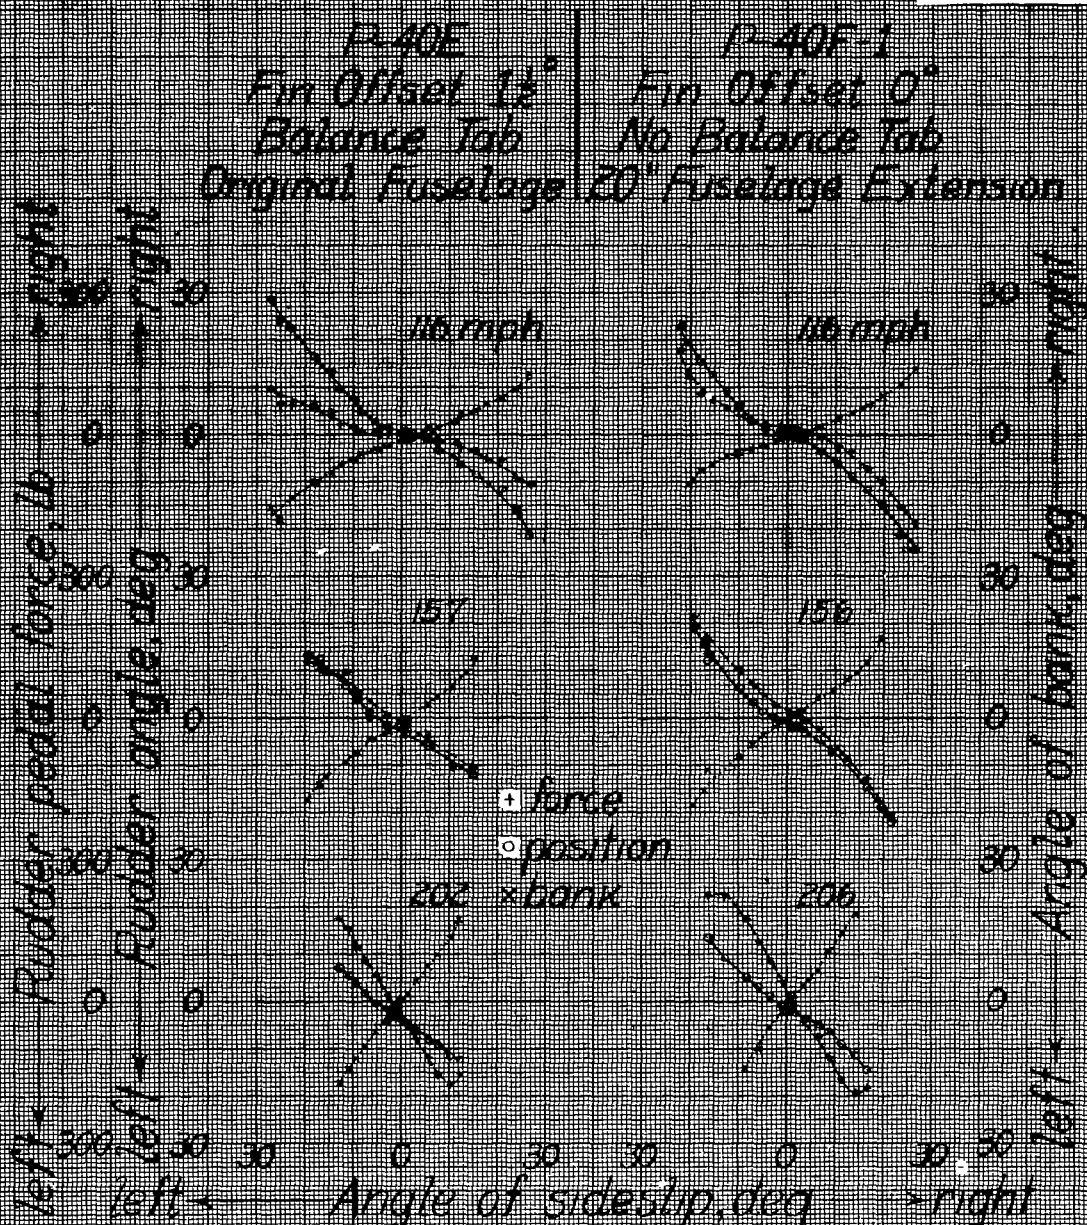
Figure 26a Sideship Characteristics of P-40E and P-40F-1 Airplanes with Original Vertical Tails at Various Indicated Airspeeds with Power Off
